Apartment Complex Fire, 66 Units Destroyed Seattle, Washington

Apartment Complex Fire, 66 Units Destroyed Seattle, Washington (September 21, 1991)

Investigated by: Philip Schaenman

**This is Report 059 of the Major Fires Investigation Project conducted
by TriData Corporation under contract EMW-90-C-3338 to the United
States Fire Administration, Federal Emergency Management Agency.**

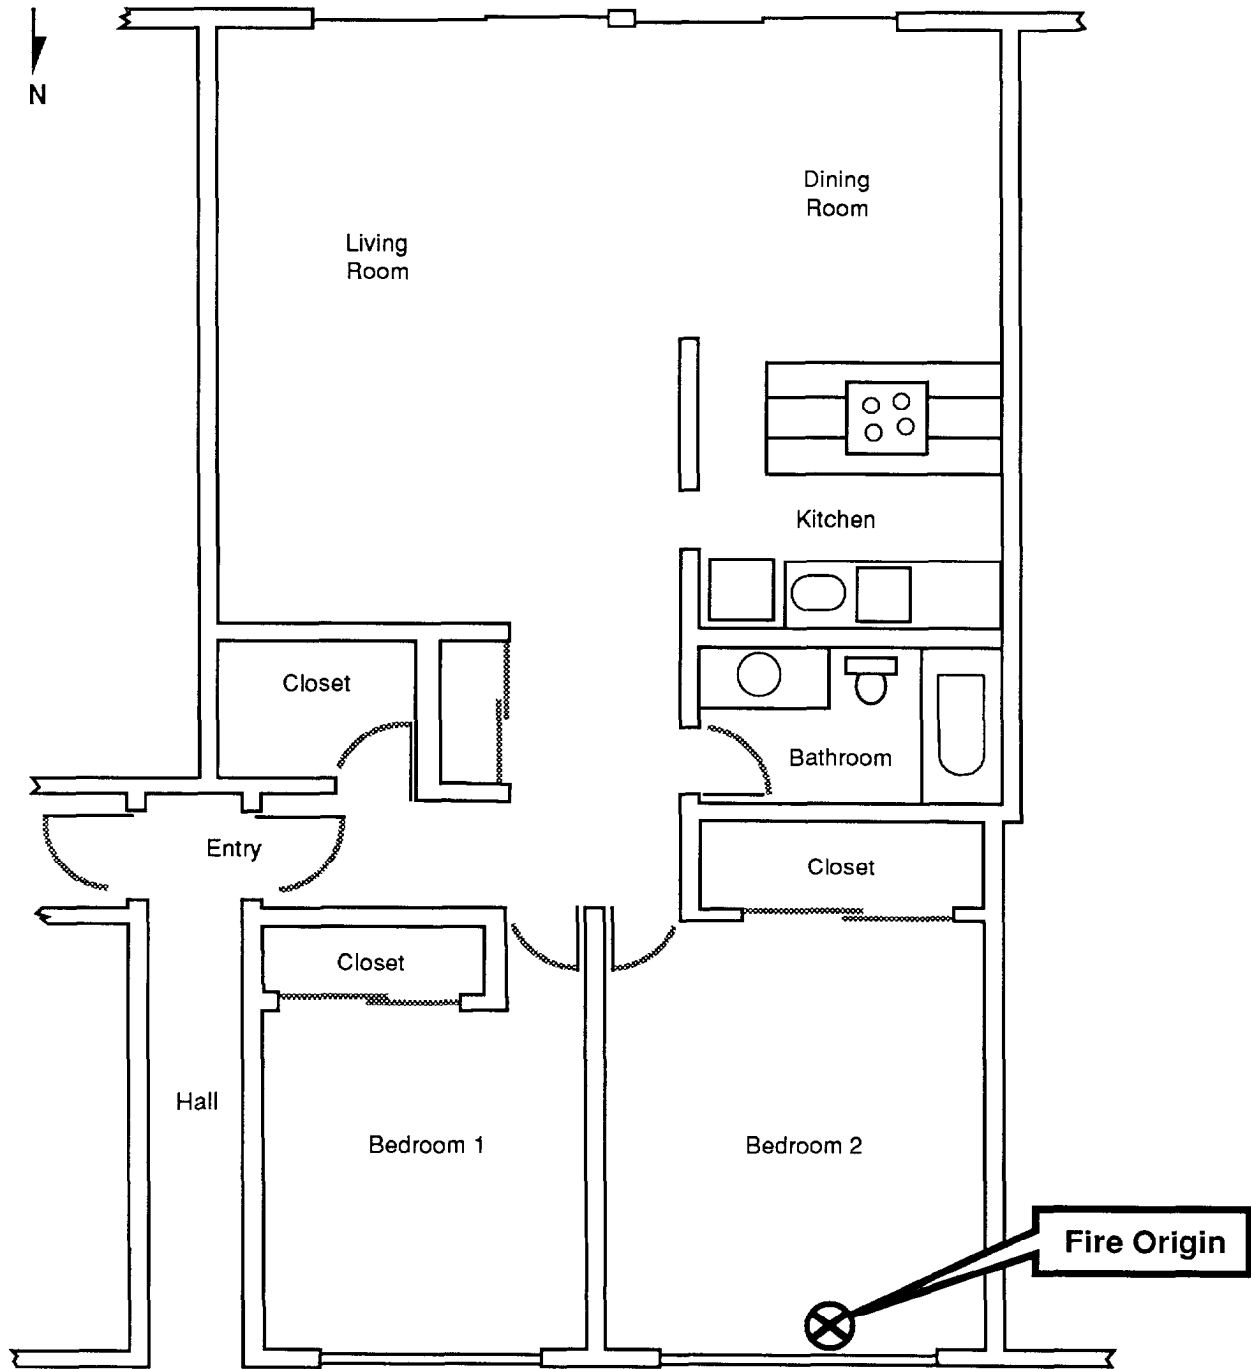
FLOOR PLAN OF APARTMENT OF FIRE ORIGIN

The candle was placed in a plate on a dresser in her bedroom. As the candle burned down, the mother kept the fire going by feeding it with some paper envelopes. When the fire flared up, she tried to blow it out, which caused flaming debris to scatter. A piece of flaming paper fell behind the dresser and ignited something on the floor -- probably clothing or the rug. (Clothes were scattered about the floor, and remnants were found by the dresser.)
